# Broadwater Power Project Jetty Replacement, Erosion Control, and Canal Intake Gates

Preliminary Engineering Report

Toston Dam/Broadwater-Missouri Irrigation  
System

*Broadwater County, MT*  
August 20, 2021

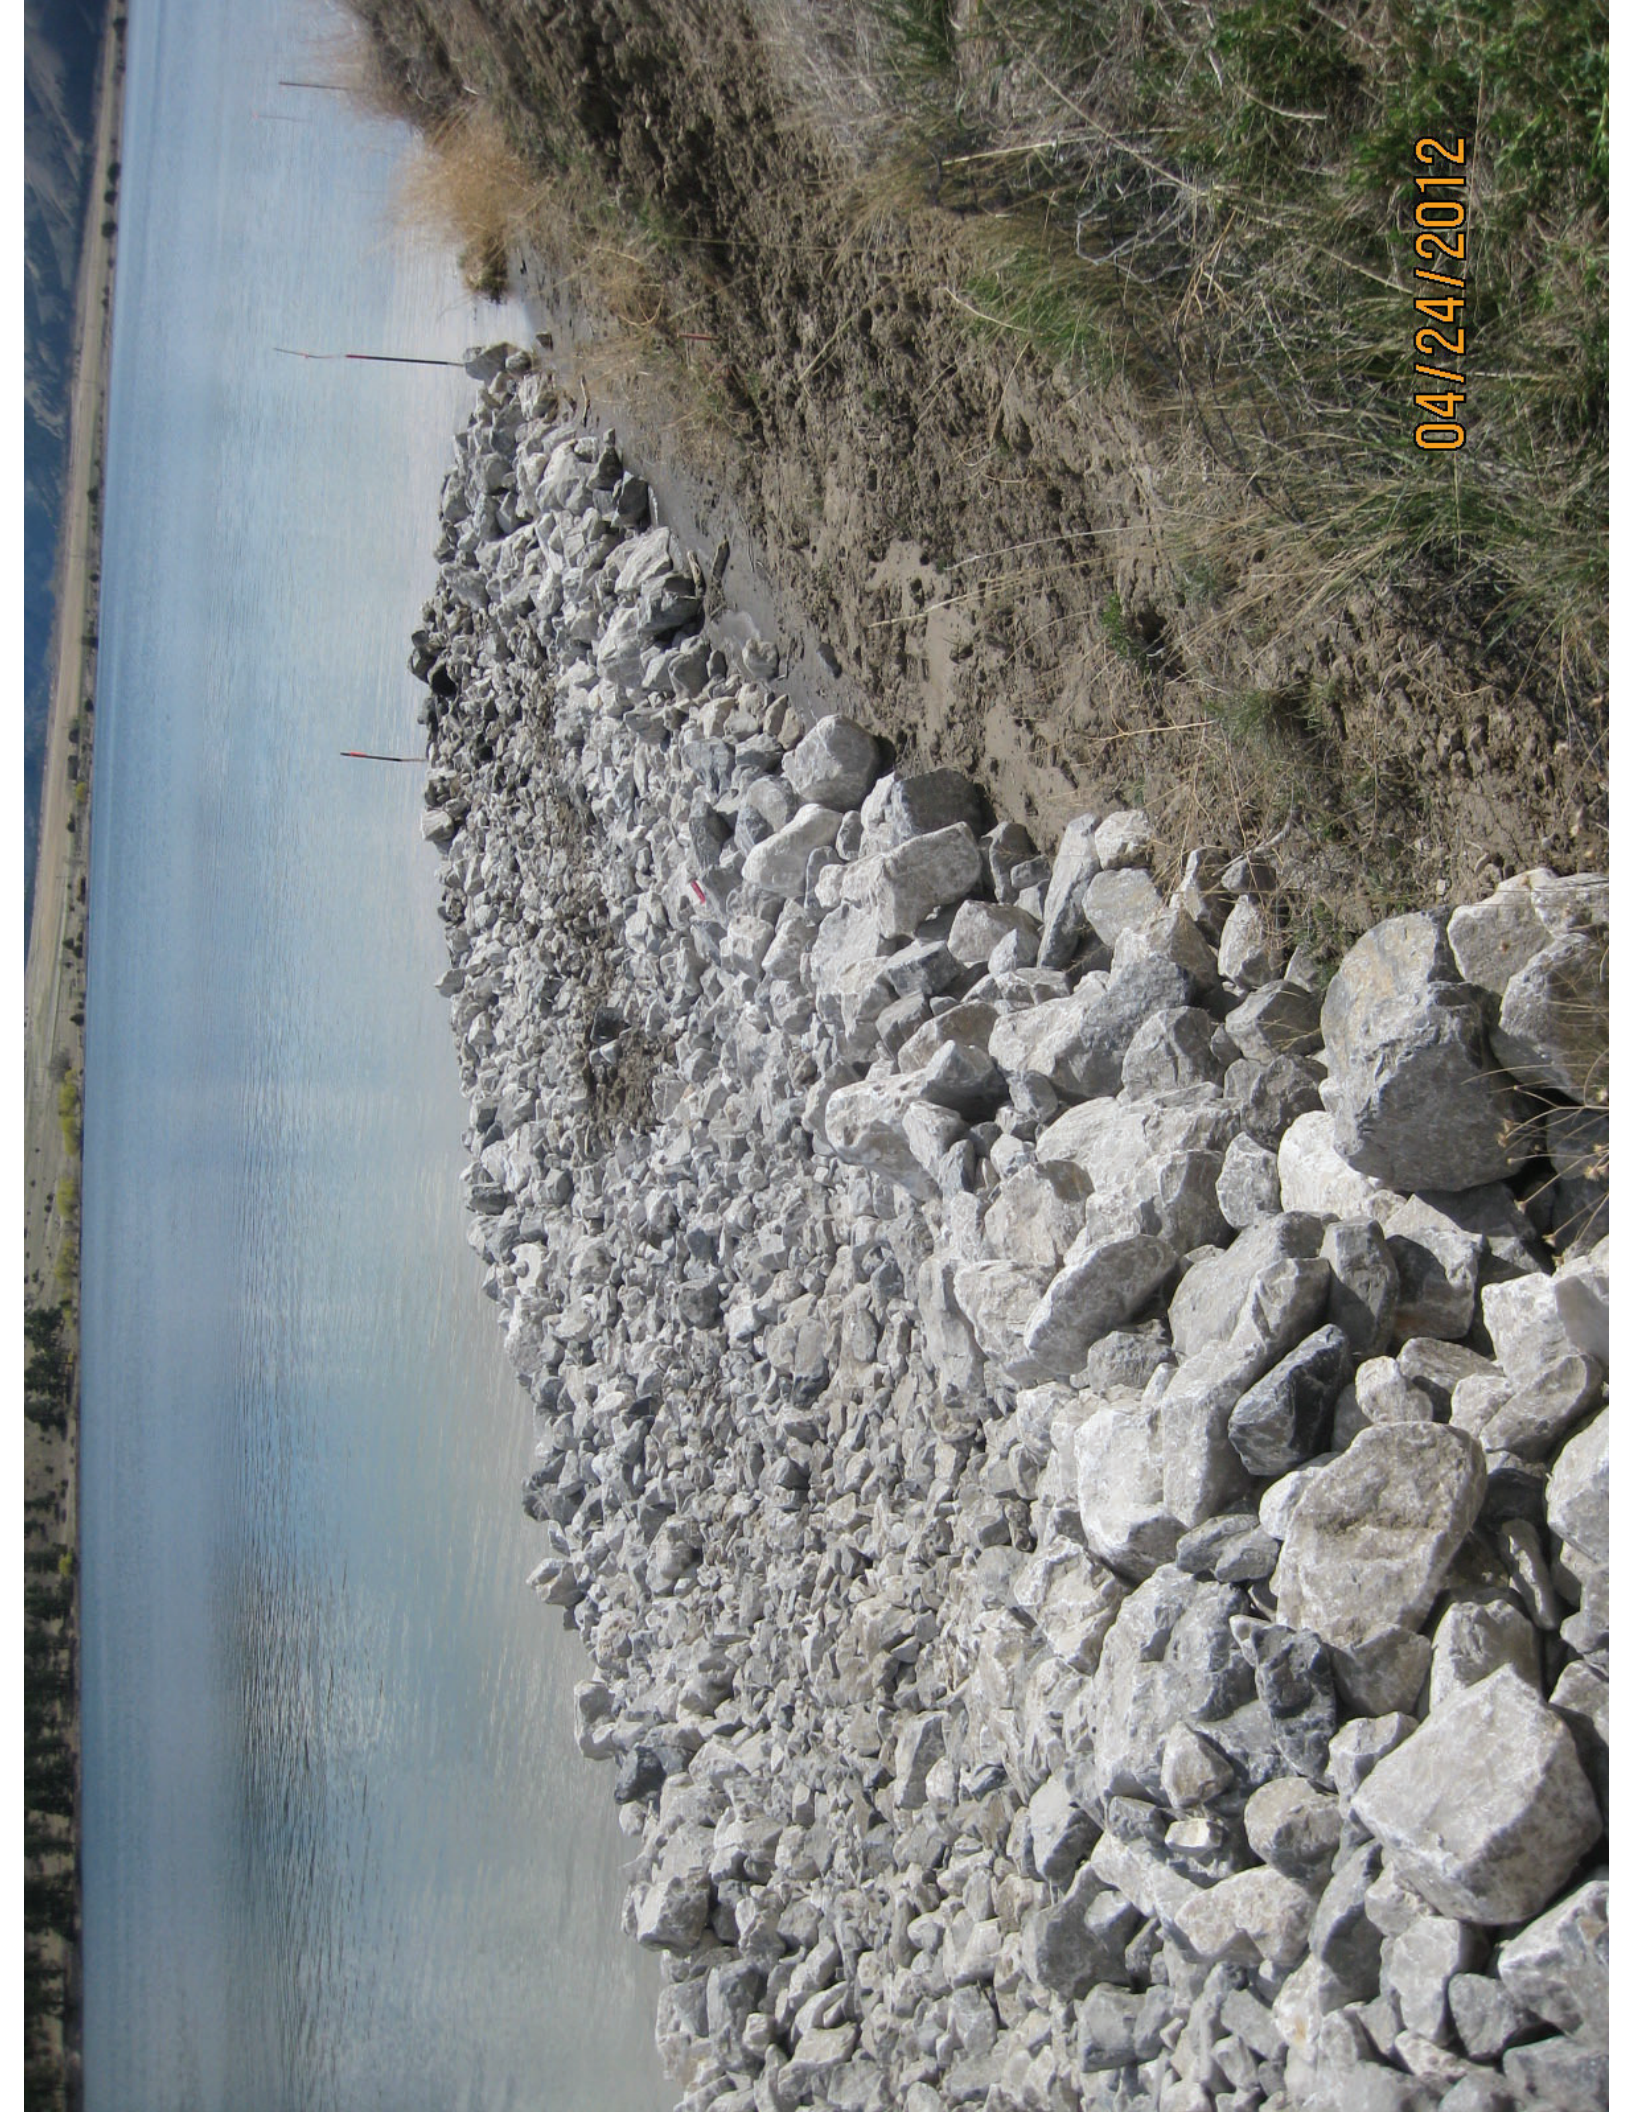
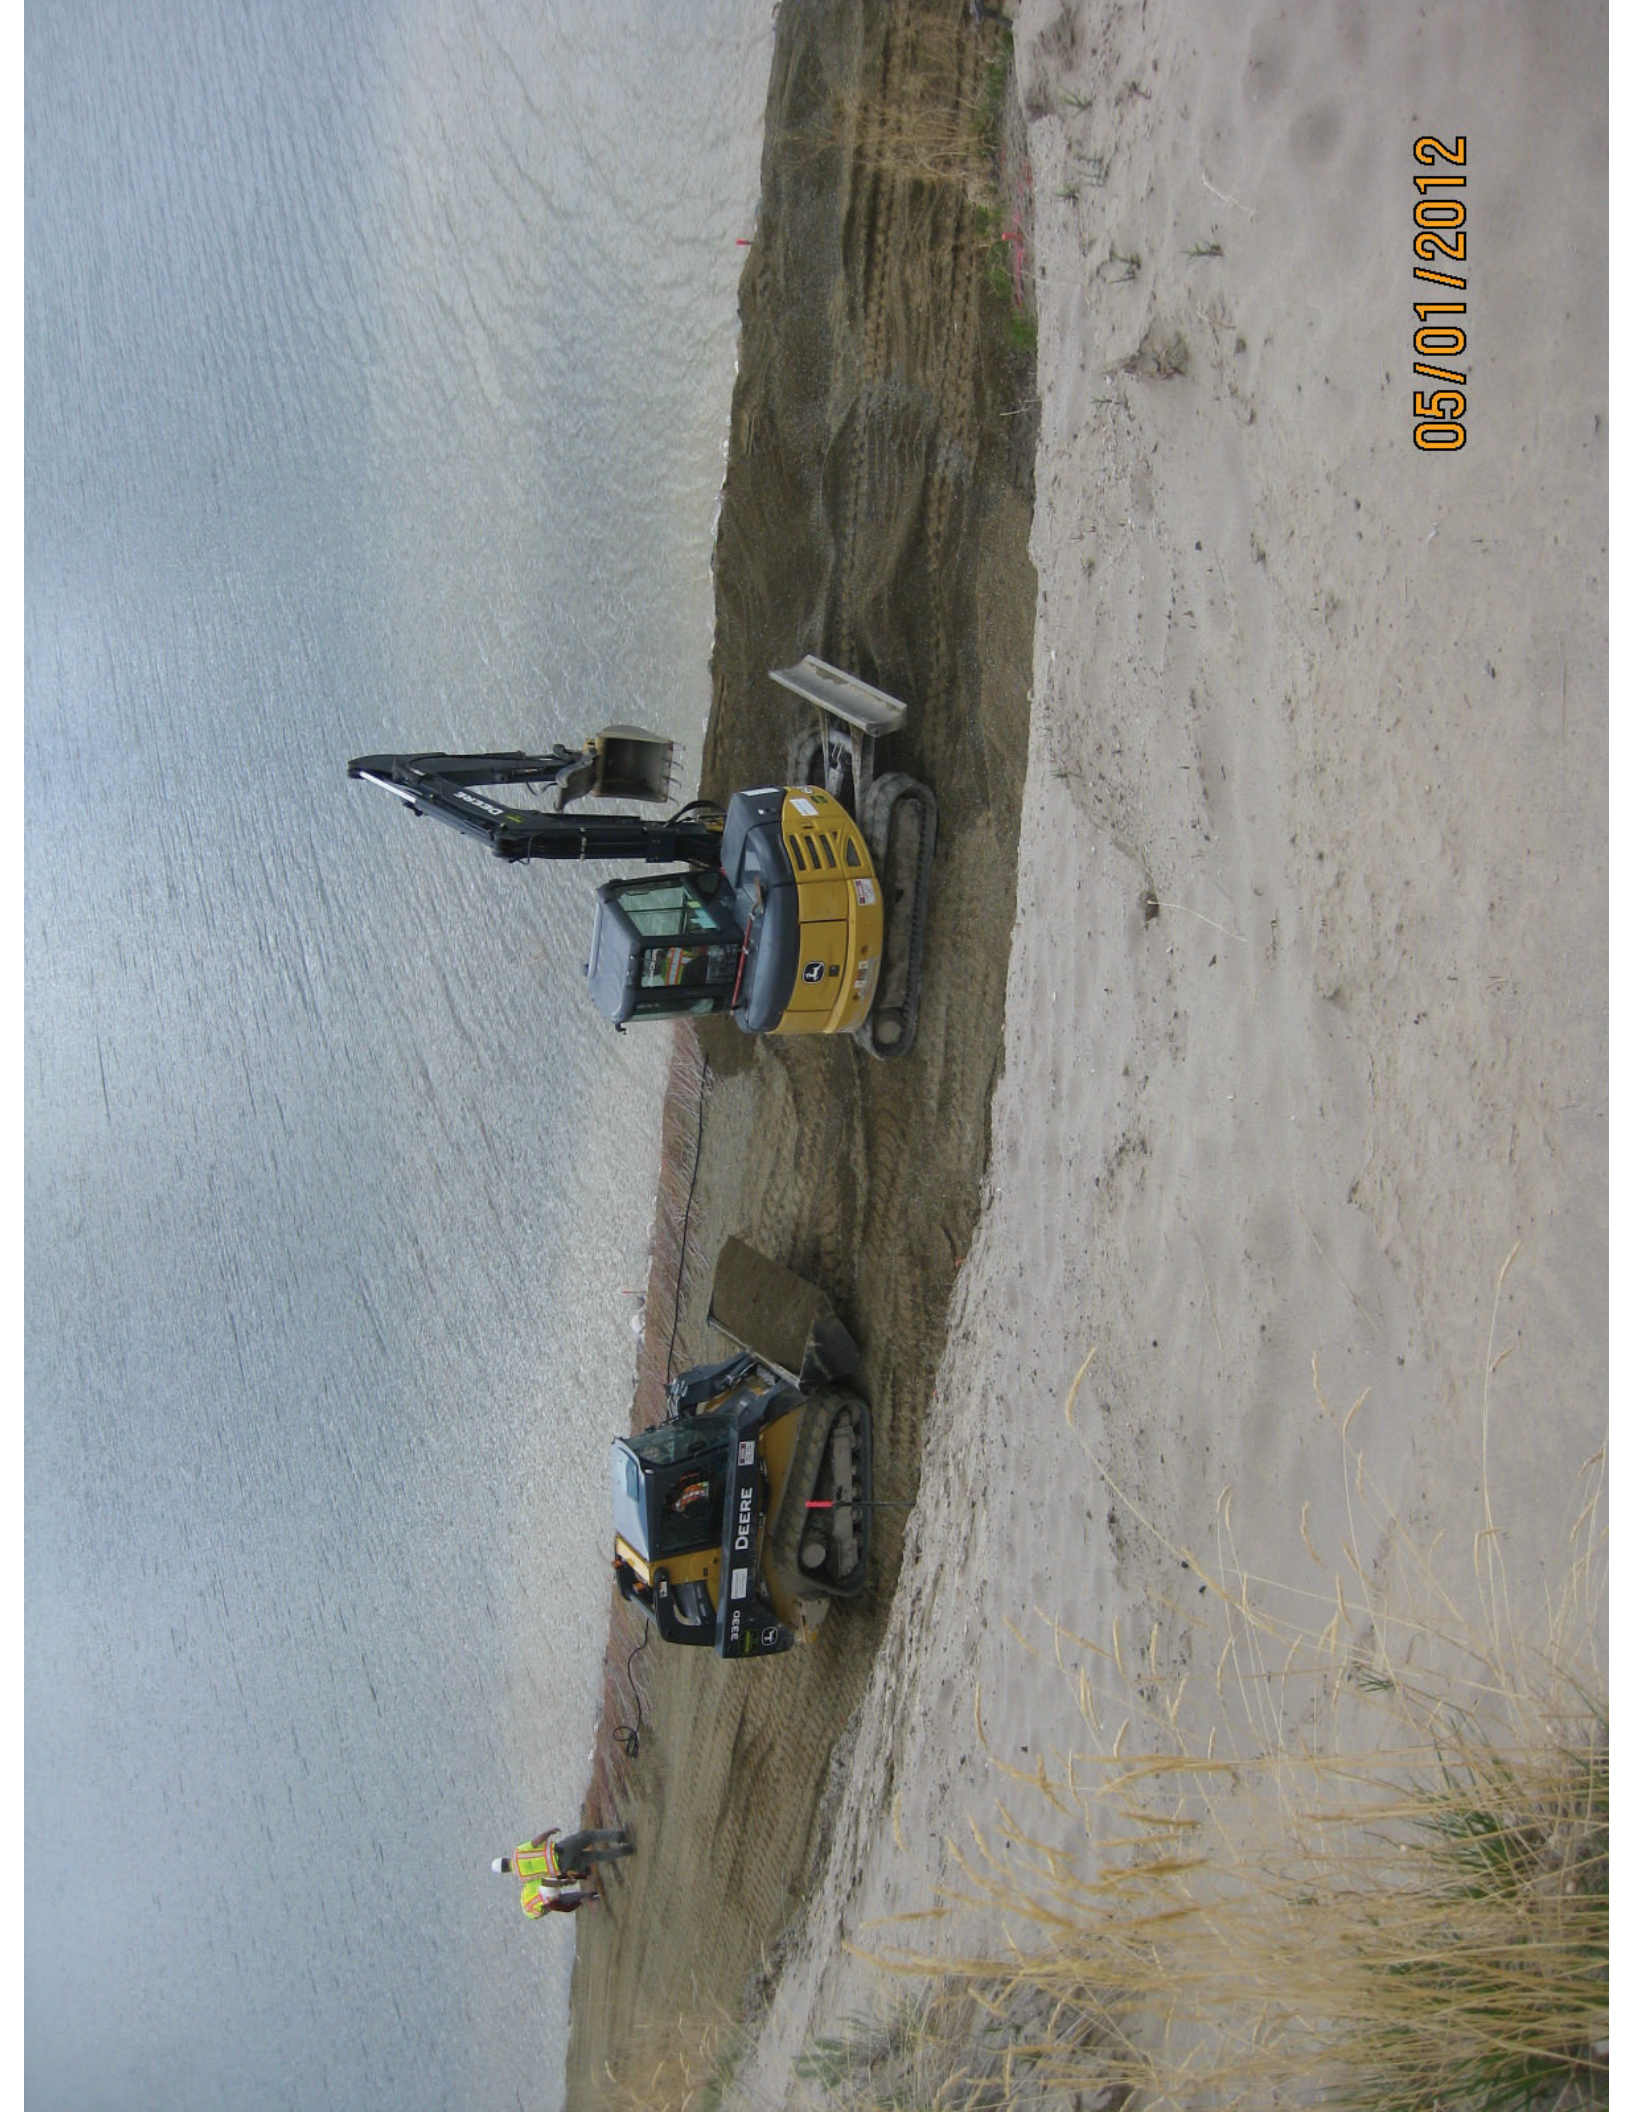
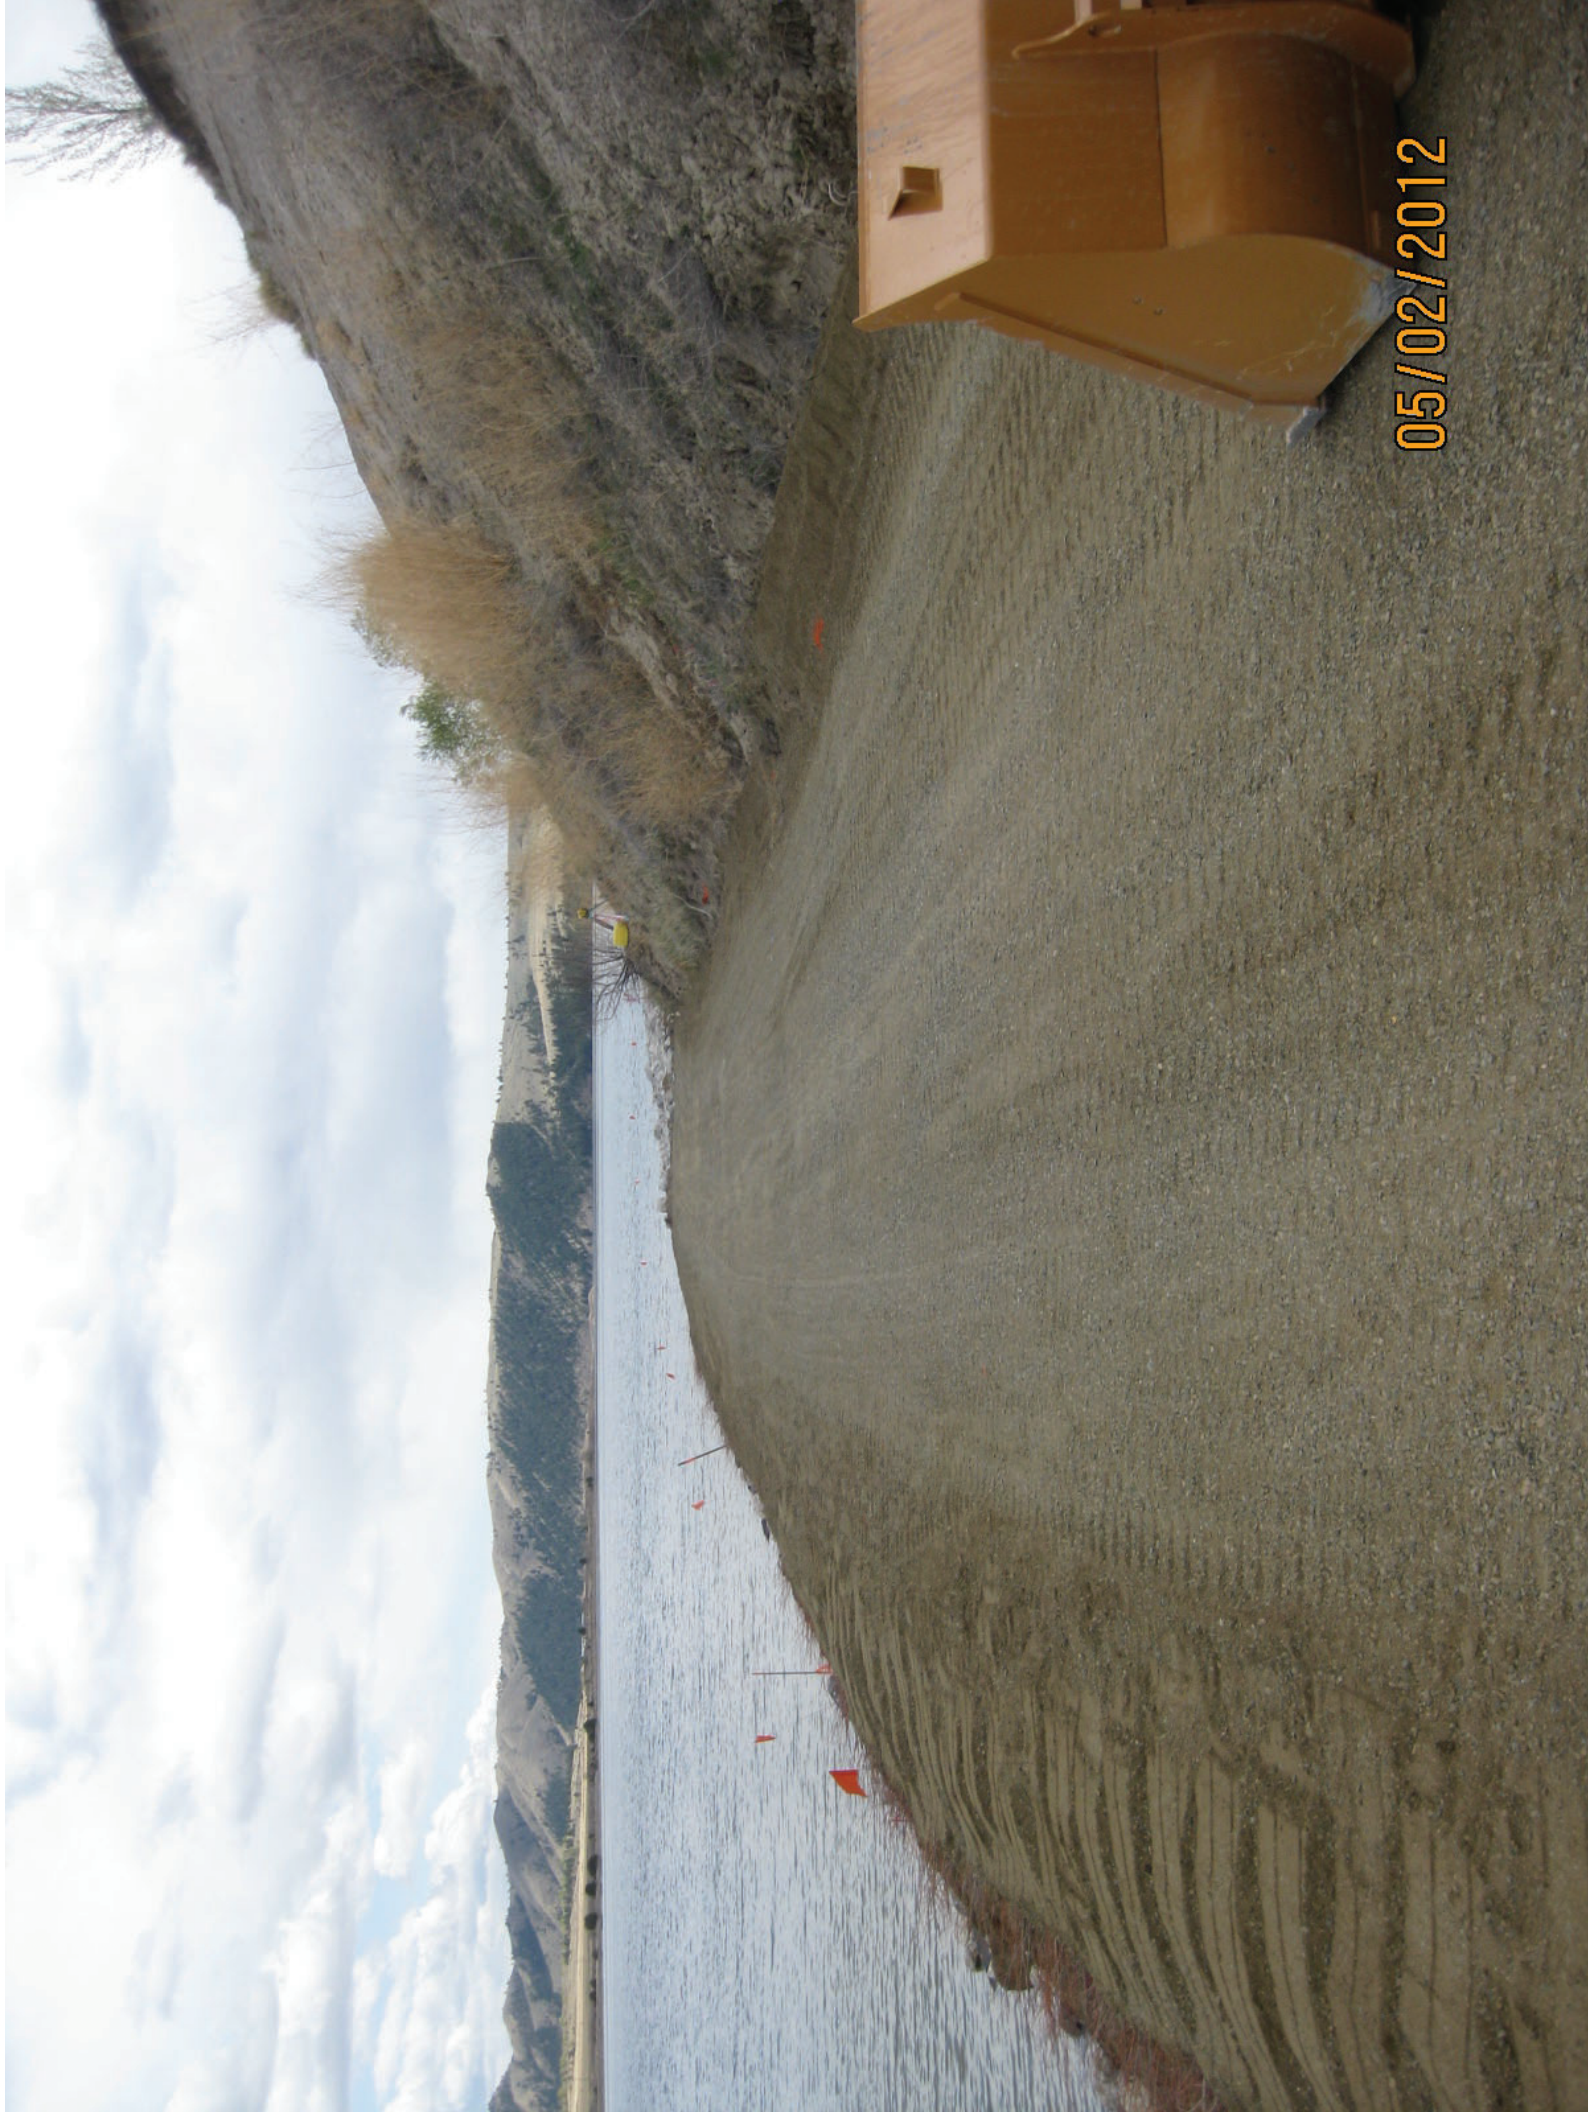
Toston Dam Recreation Area Conceptual (1)  
Bank Stabilization Photos (4)

- Utilize rock revetment by placing stone materials – with a low tolerance for movement – to stabilize the existing bank and restore missing sections of shoreline that have been lost to erosion. Materials that are adequately sized for stream and shoreline protection are strongly recommended. BLM also recommends placement of revetment materials at a minimum of ten feet outside of the existing Toston Dam Recreation Site shoreline. District engineering recommends placing revetment materials at a minimum of 12 inches above the existing river elevation (full pool). It's also recommended that a new bank zone is established and gradually shaped upward to match or tie into the existing line and grade of the existing bank. HDR engineering, which is taking the lead on project design, seems to be well versed in this work and we encourage its input and expertise as to the lines and grades of this material. See Attachment 1 for a site plan showing the area that BLM recommends to be stabilized. Attachment 2 shows a similar project in which a new bank zone was established.
